Report No. NA-64-758

Title: Investigation of long term exposure effects under stress of supersonic transport structural materials.

INVESTIGATION OF LONG TERM EXPOSURE EFFECTS
UNDER STRESS ON SUPERSONIC TRANSPORT STRUCTURAL
ALLOYS

Prepared under Contract No. NASw 746 by
NORTH AMERICAN AVIATION, INC.
Los Angeles Division, Los Angeles, Calif.

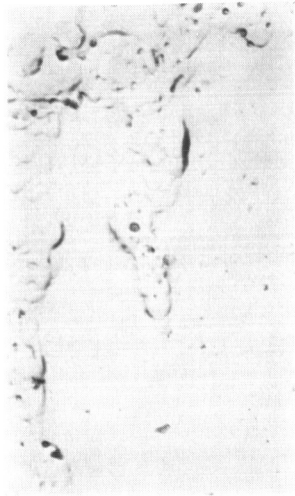
15,000 HOUR EXPOSURE
FAILED

Two stage replica

x 15,000

Figure 9 .- Microstructure of Salt Coated Titanium 6Al-4V Alloy after exposure in circulating air at 650°F. (Specimens AB1 and AB2)

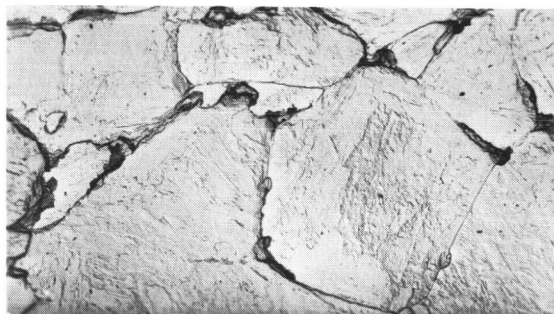
Etched

x 500

Figure 14.- Microstructure of AM 350 M Steel
prior to exposure to test environment.

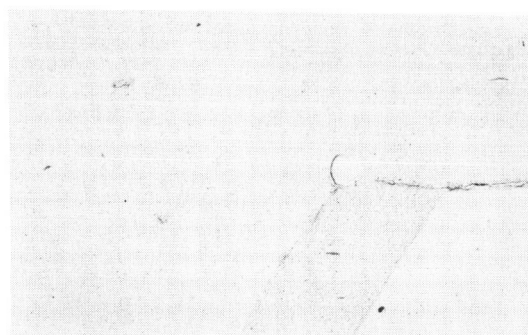
Figure 16 .- Microstructure of Inconel 718 Alloy
prior to exposure to test environment.

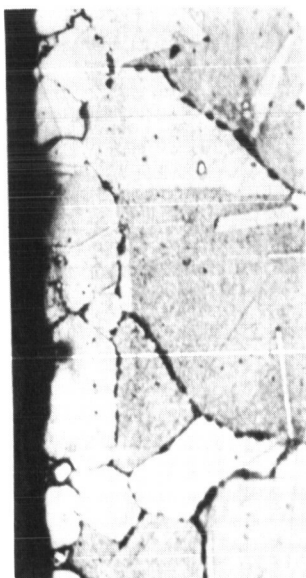
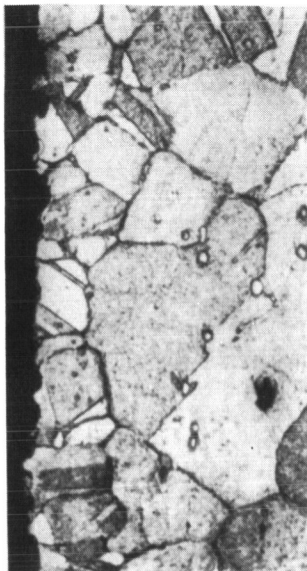
Figure 17.- Microstructure of Salt Coated Inconel 718 Alloy after exposure in circulating air at 650°F. (Specimens EB1 and EB2)

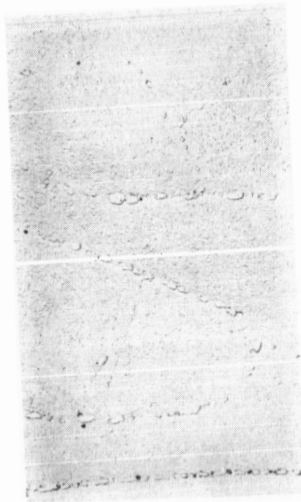
10,000 HOUR EXPOSURE
NO FAILURE

Etched x 500

Figure 19.- Microstructure of Salt Coated Rene' 41 Alloy after exposure in circulating air at 650°F. (Specimens FB1 and FB2)

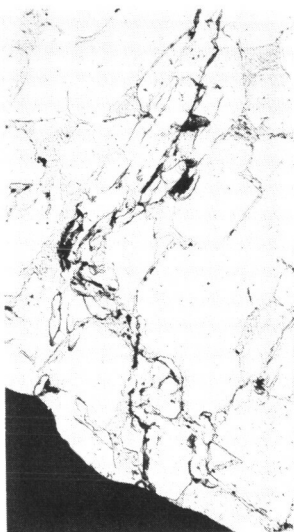
15,000 HOUR EXPOSURE
FAILED

Etched x 500

Figure 34.- Microstructure of Braze and Salt Coated Titanium 6Al-4V Alloy after exposure in circulating air at 650°F. (Specimens AD3 and AD5)
